Table DR1: 1912 Mürefte earthquake co-seismic slip measurements. DGPS is differential GPS and TS is for total station measurement.

Figure DR1: Surface faulting documented near Mursalli village (Mihailovic, 1927; for location see Fig. 2). The sketch map on the right illustrates the rupture zone geometry where the principle displacement zone and Riedel shear are apparent.

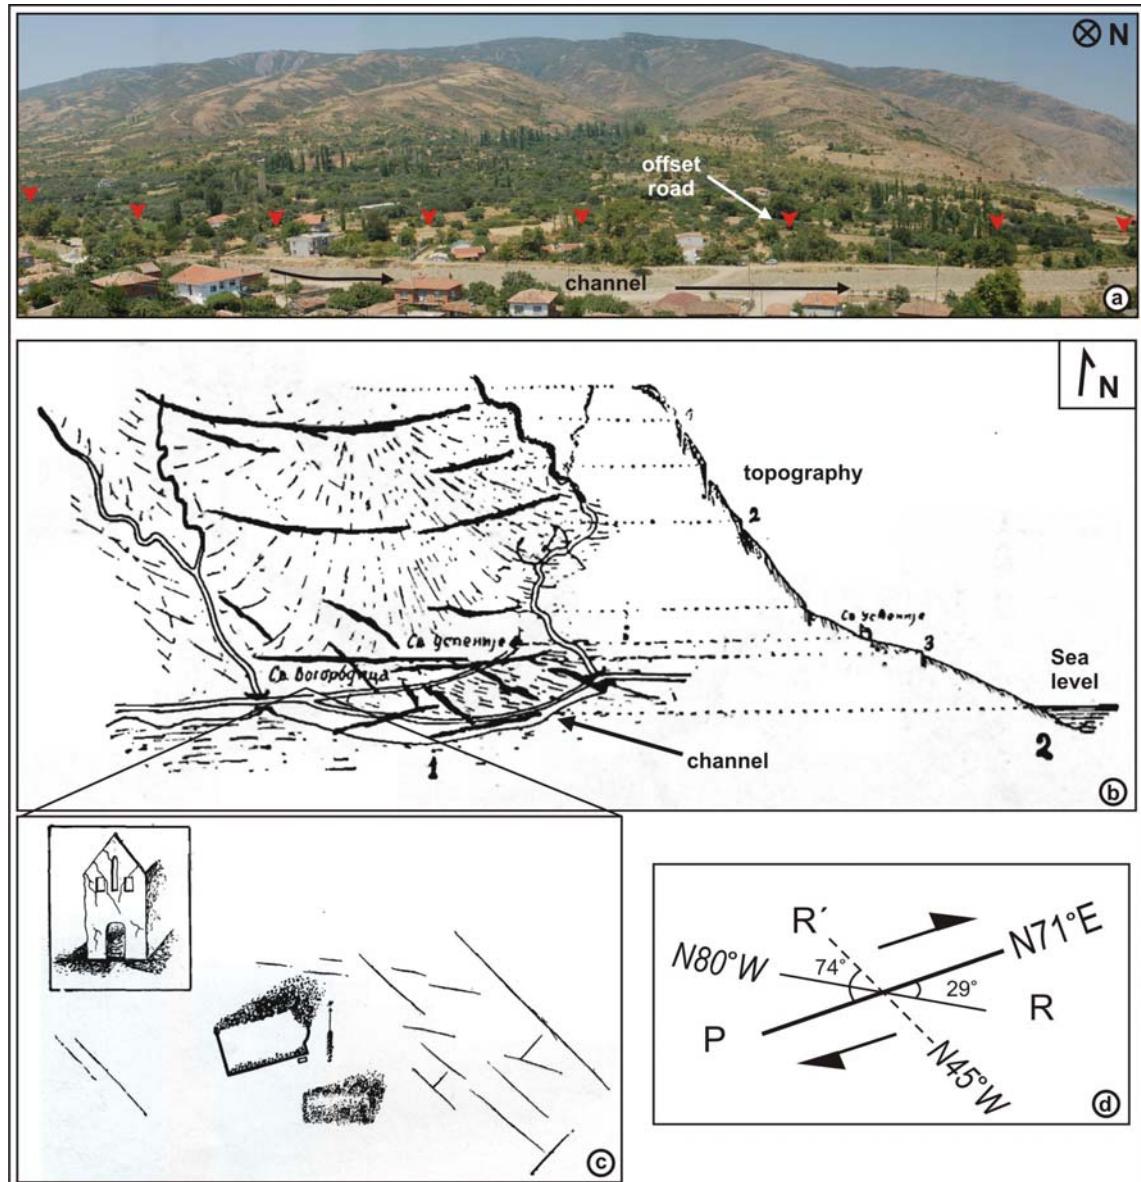
Figure DR2: The upper image shows the eastern most onland section of the Ganos fault, next to the Gaziköy village where we measured 3 to 5 m right lateral displacement (Fig. DR4). Figure b illustrates surface deformation at Gaziköy (Mihailovic, 1927). The E-W trending fractures just north of the channel are in accordance with the principle displacement direction and Riedel shear (Fig. d), while the arc-shaped fractures uphill are most probably secondary structures like tension cracks or slope failure.

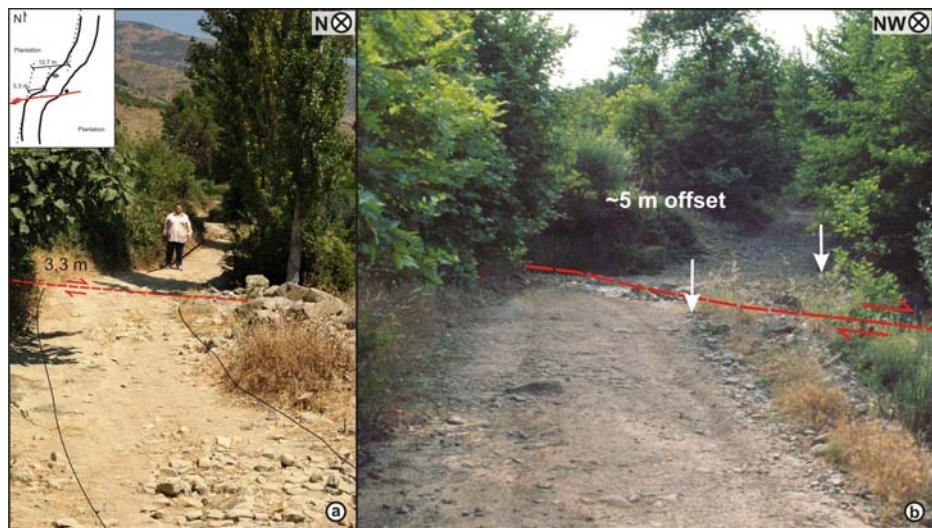
Figure DR4: Two right-lateral road offsets measured near the Gaziköy village. Left image shows an ancient pavement with $3.3 \text{ m} \pm 0.5 \text{ m}$ co-seismic and $12.5 \text{ m} \pm 1\text{m}$ cumulative displacement (see Figure DR2a for location). The road on Figure b corresponds to $5 \text{ m} \pm 0.5$ right-lateral co-seismic offset.
