Supplementary Information

1. Geomorphology

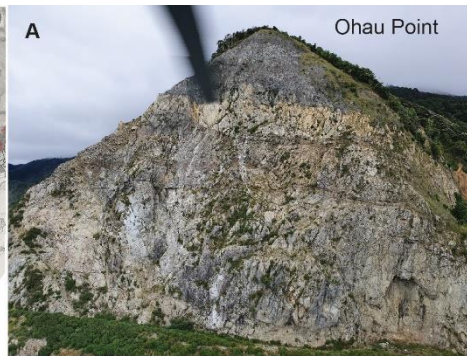
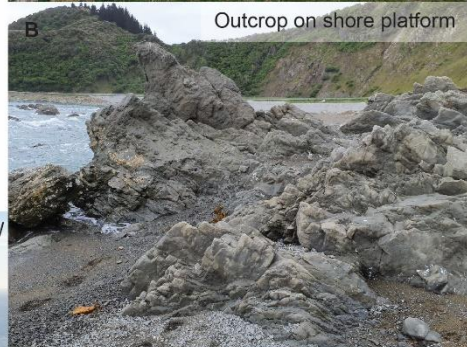
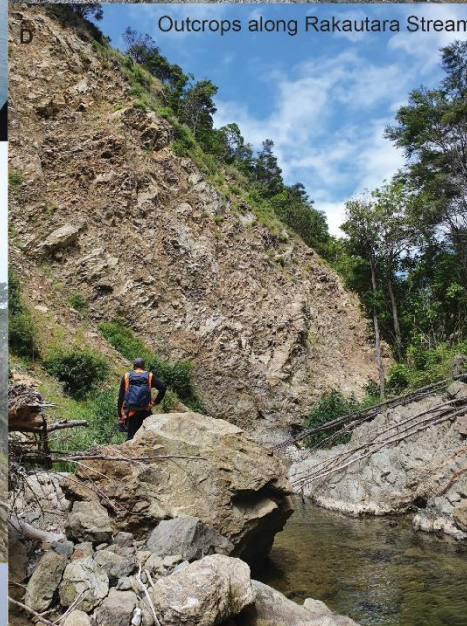
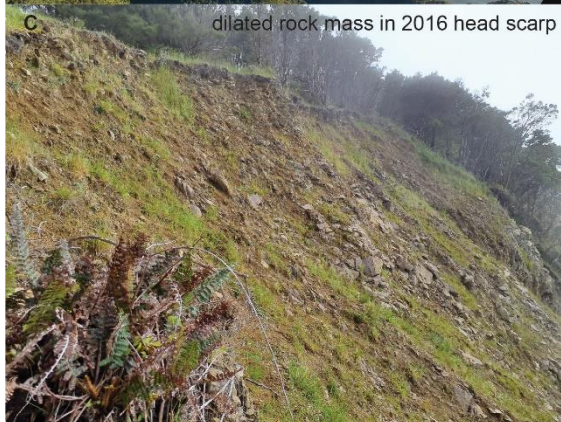
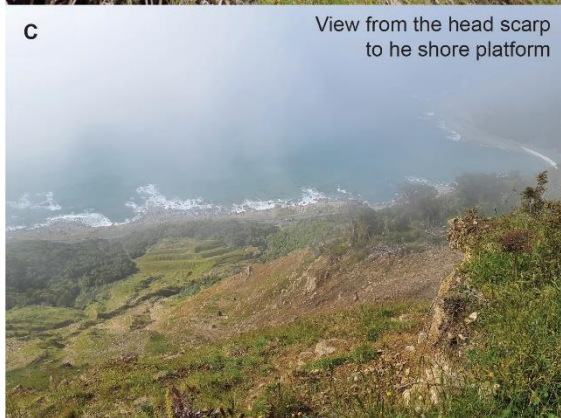
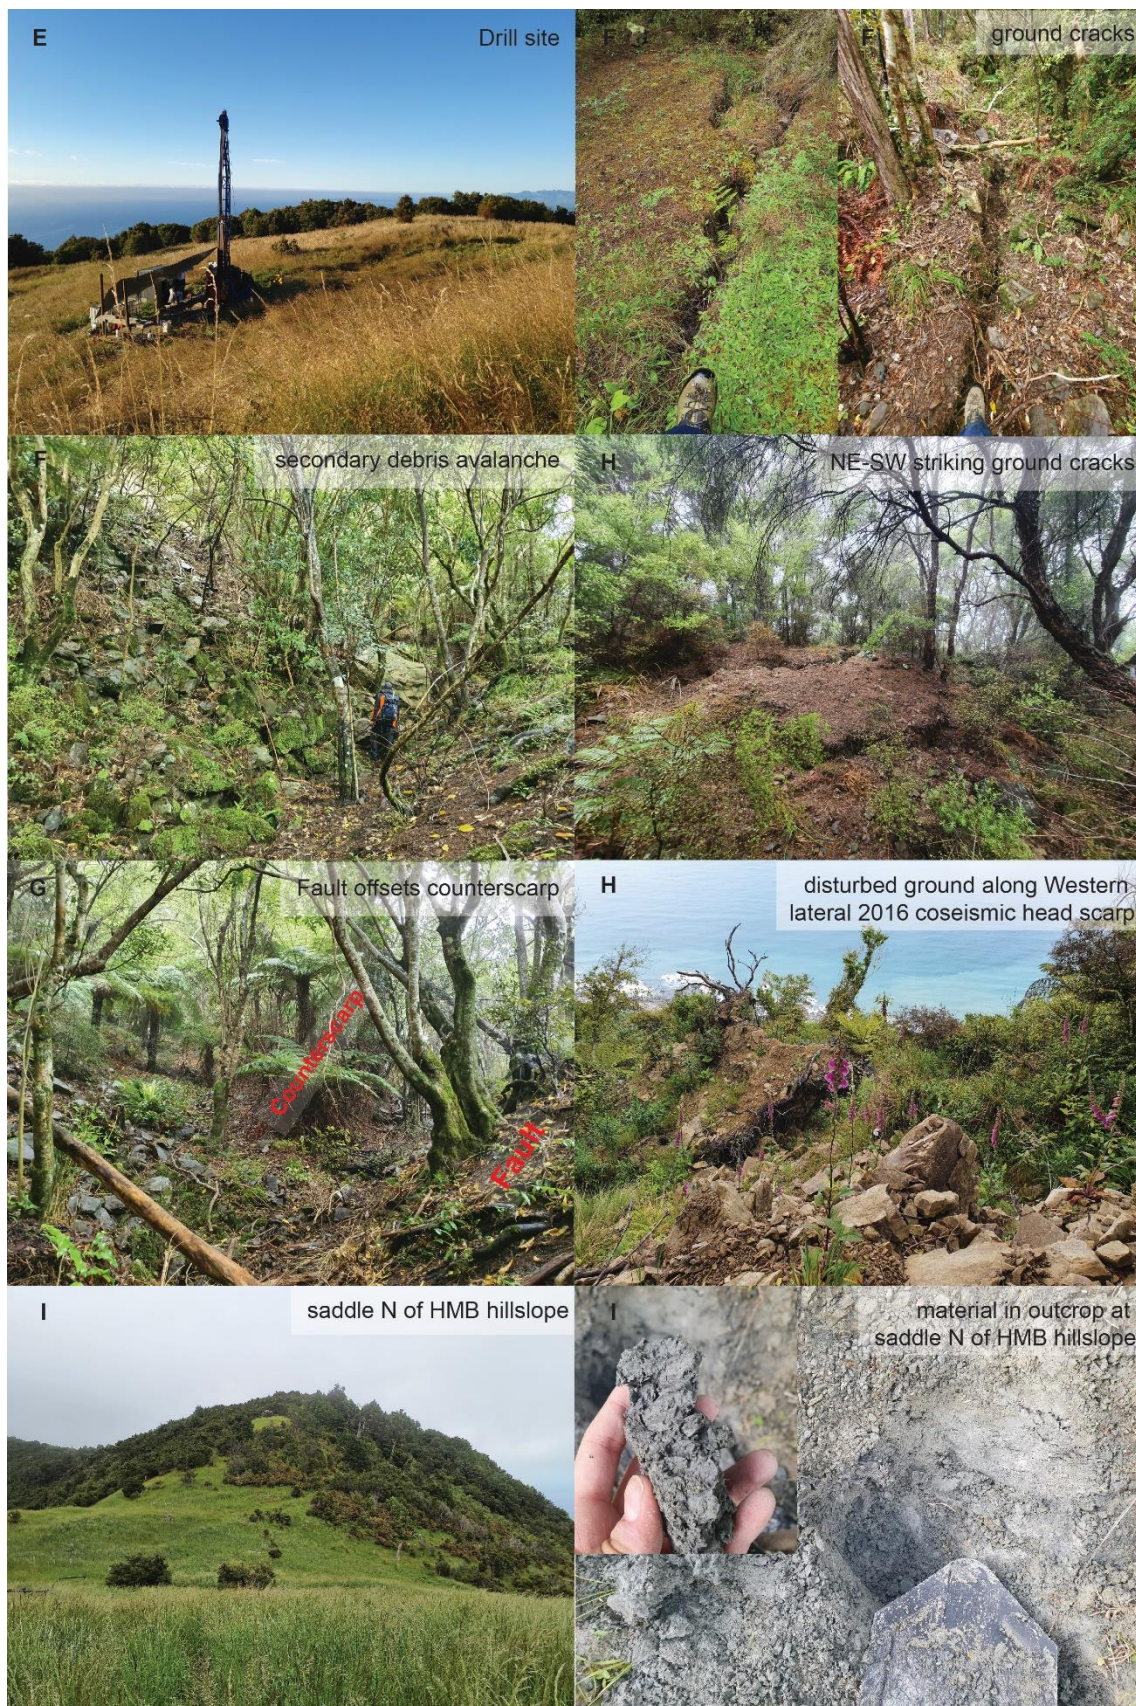
Figure S2: Field photos to illustrate observations regarding morphology, slope deformation and rock mass characteristics.

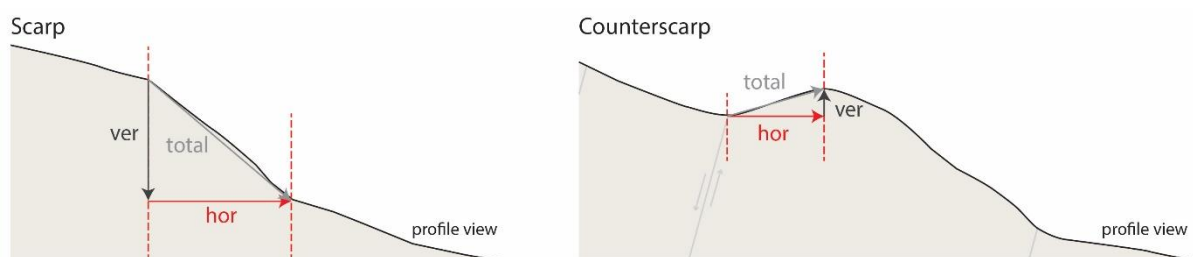
Figure S3: Schematic cross-section of how displacements were derived from scarp and counterscarp features along topographic profiles. The horizontal displacement estimate is based on the interpretation of changes in slope (indicated in red), and the vertical displacement is based on the resulting change in surface elevation (indicated in dark grey). The total surface displacement vector is indicated in light grey.
