ENTRAINMENT OF DEBRIS IN ROCK AVALANCHES; AN ANALYSIS OF A LONG RUN-OUT MECHANISM

Oldrich Hungr and S.G.Evans

SUPPLEMENTARY FIGURES

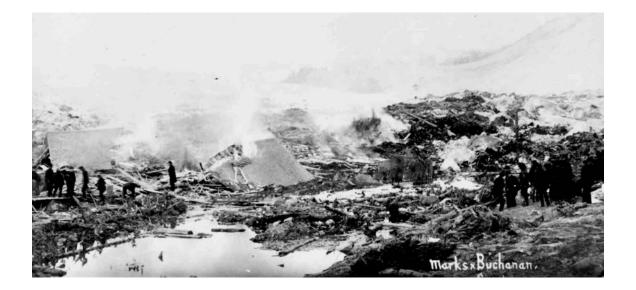
Figure 1

Damage to homes at the site of the 1903 Frank Slide. Destruction caused by mud expelled from valley bottom by impact of rock avalanche debris. The main deposit is seen in the background, obscured by dust or smoke (Glenbow Archives, Calgary, Alberta; Photograph NA-3437-5).

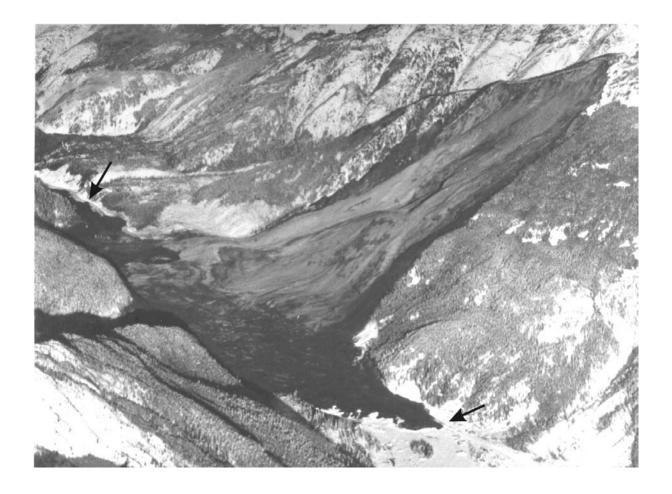
Figure 2

Mud, consisting of liquefied alluvium, was expelled laterally (arrows) from the deposit margins of the 1964 Hope rock avalanche in southwestern British Columbia, Canada. The western (upper) debris tongue traveled more than 10 km down the valley (Mathews and McTaggart, 1978).

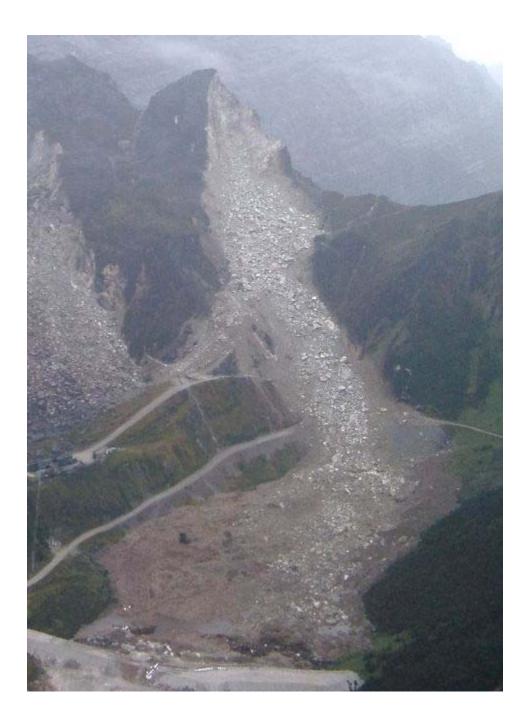
Figure 3

A rock slide-debris avalanche caused by mining induced subsidence in limestone, Iryan Jaya, Indonesia. Note light-coloured rock fragments, distinct from brown-coloured entrained colluvium (Photo, O.Hungr).

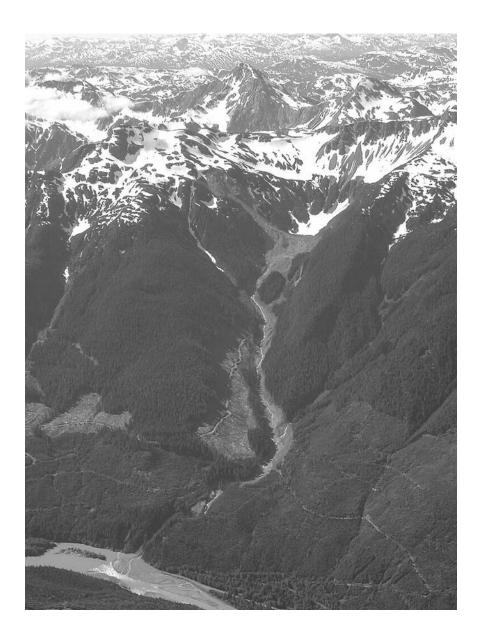
Figure 4

The Zymoetz rock slide-debris avalanche which took place in the spring, 2002 near Terrace, northern British Columbia, Canada. The initial rock slide, seen above the centre of the photo, triggered a flow of liquefied debris that reached as far as the Skeena River, building a temporary fan. (Photo, S.G.Evans)

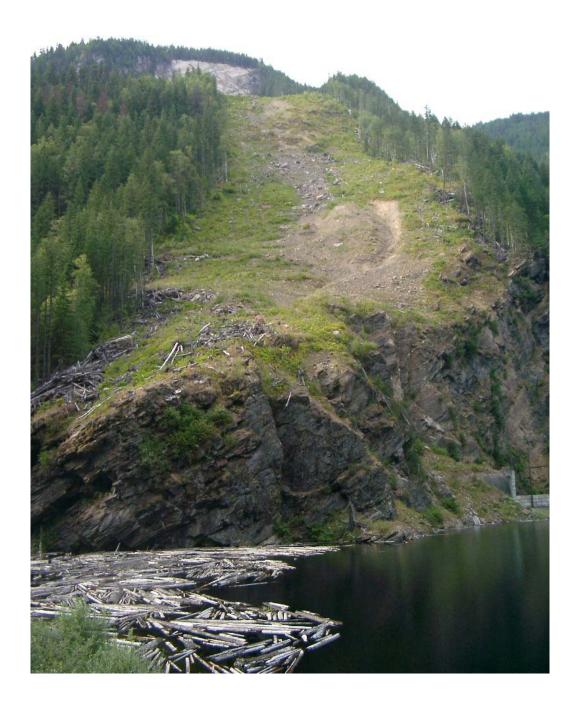
Figure 5 Overall view of the Eagle Pass rock slide-debris avalanche, taken in August, 2003. (Photo, O.Hungr)

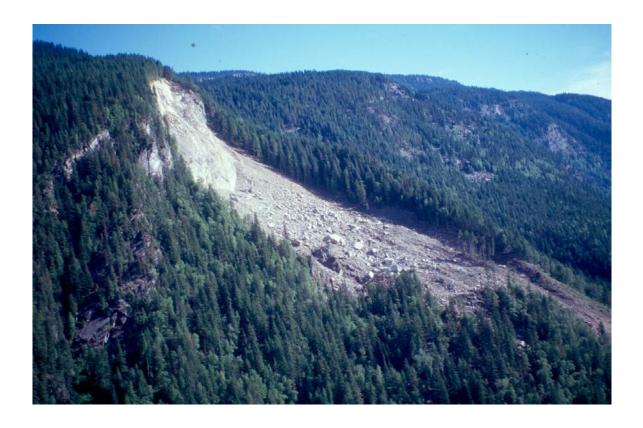
Figure 6

Eagle Pass, coarse fragmented rock deposits on the bench below the source area. The largest boulders are several metres in diameter. (Photo, D.Ayotte).

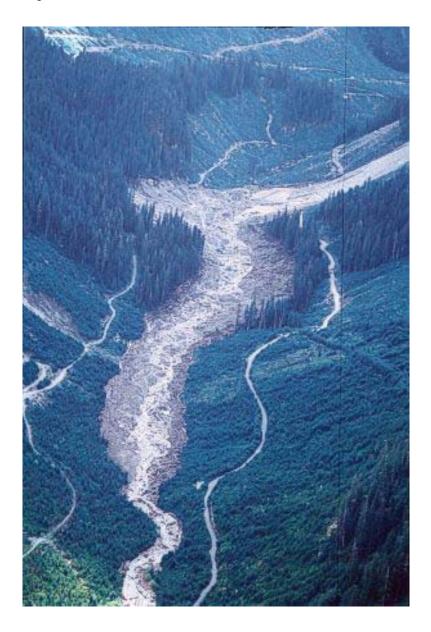
Figure 7 Nomash River, overall view (Photo, D.Ayotte).

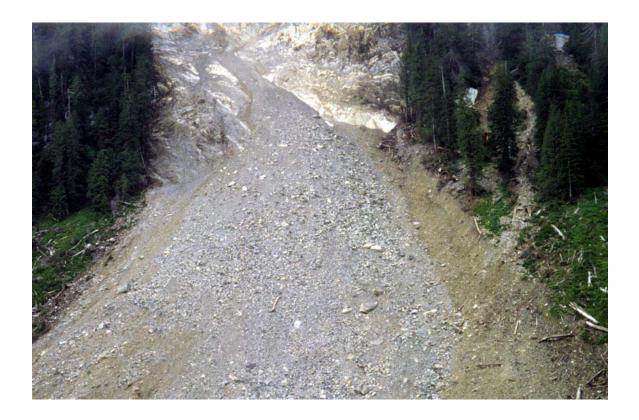
Figure 8

Nomash River, eroded scarp in the colluvial apron beneath the source area. Maximum erosion depth at this location is approximately 8m. A similar scarp on the opposite side of the slide path is partly covered by debris. (Photo, O.Hungr)

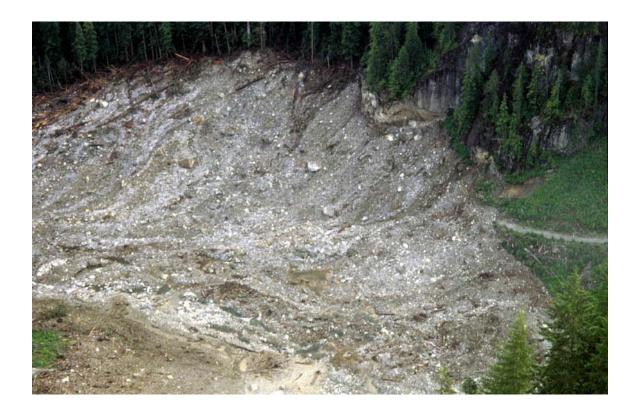
Figure 9

Nomash River, path curvature at approximately 750 m distance from the slide crown. The maximum runup at this location corresponds to a velocity of 22.m/s (see Equation 2). (Photo, O.Hungr)

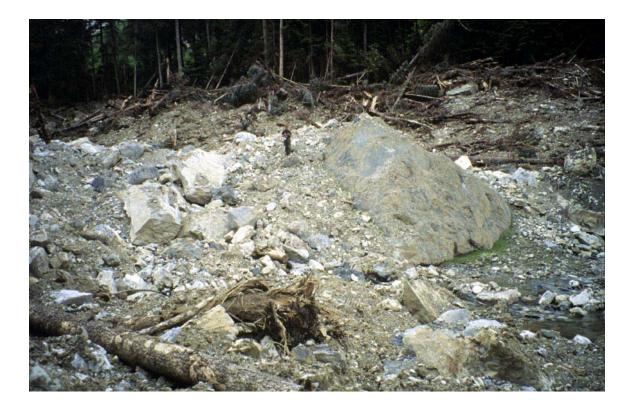
Figure 10

Nomash River, coarse rock fragments at approximately 1000 m distance from the slide crown. This is near the distal limits of the bulk of the coarse rock deposits. Note person for scale. (Photo, D. Ayotte)

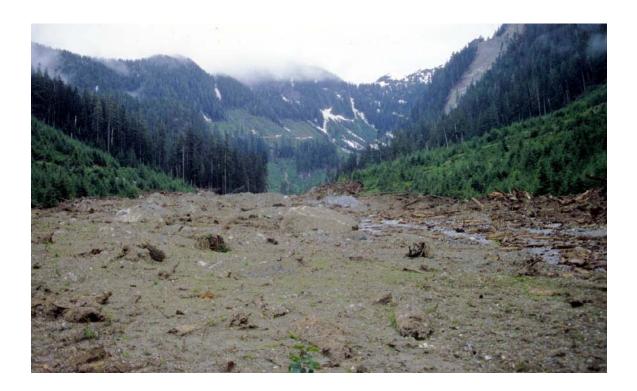
Figure 11

Nomash River, fine-grained debris at approximately 1300 m distance from the slide crown. The deposit is approximately 200 m wide at this location. (Photo, O.Hungr)

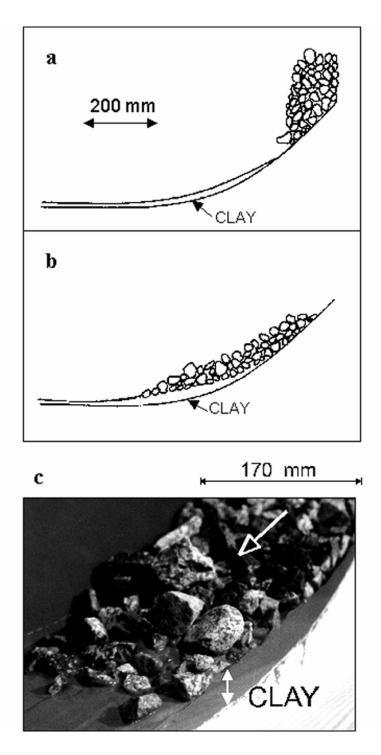
A scaled drawing of a physical model of liquefaction and entrainment of saturated substrate from the path of a rock slide. The substrate model material is a clayey silt, placed at a water content near the Liquid Limit. The rock material is medium to coarse gravel. a) beginning of experiment, b) end of experiment, c) close up of the rock mass front, showing over-riding and partial displacement of the substrate.
