ANALYSIS AND DESIGN OF HIGHWAY CUTS IN ROCK:  
A SLOPE STABILITY STUDY ON INTERSTATE ROUTES 279  
AND 79 NEAR PITTSBURGH, PENNSYLVANIA

Report Prepared by the University of Pittsburgh

Principal Investigator	J. V. Hamel
Co-Investigator	N. K. Flint

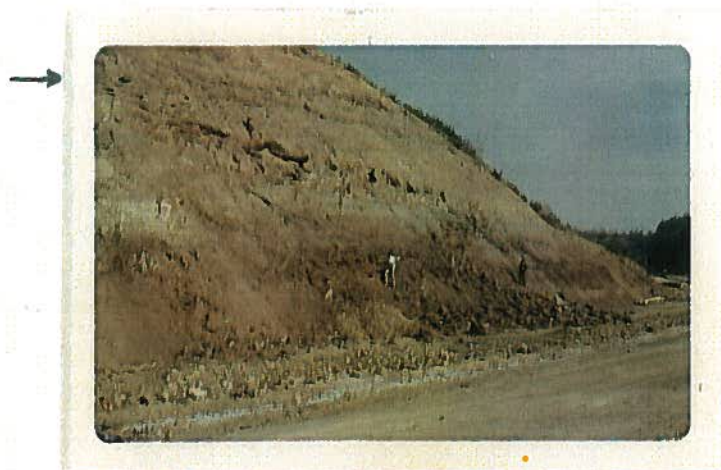
Figure 4-3

The Pittsburgh Redbeds on I-279 between  
Sta. 980 and 990; arrow points to Ames  
Limestone outcrop; Nov. 1, 1968

The term "redbed" is somewhat misleading in describing this unit. In addition to red coloration, it has a variety of other colors including gray, pale green, greenish gray, and purple. Perhaps dull red is dominant. These colors are irregularly dispersed through the bed both vertically and laterally except that the upper few feet just below the Ames Limestone appear to be predominantly gray. What is more uniform than its color is its texture and lack of bedding. The unit is predominantly very fine-grained, and is highly fractured in random directions. Slickensides along fracture planes are very abundant. Small limestone nodules are scattered through a part of the unit in some places. Because there is no bedding or fissility, the unit cannot be correctly called shale, which by definition has fissility. This distinction between the non-bedded, randomly fractured redbed-type lithology and the bedded-shale-type lithology is very important from the engineering standpoint because redbeds are generally weaker than shales. It is also important to relate the position of such weak strata to proposed highway cut slopes. Because the Pittsburgh Redbeds are so important in engineering geology studies, a plot of their position (i.e. a geologic map) should be made along the route of a proposed highway. Examples of such plots are shown on I-279 (Figs. 4-8 and 4-10) and on I-79 (Figs. 4-12 and 4-14).

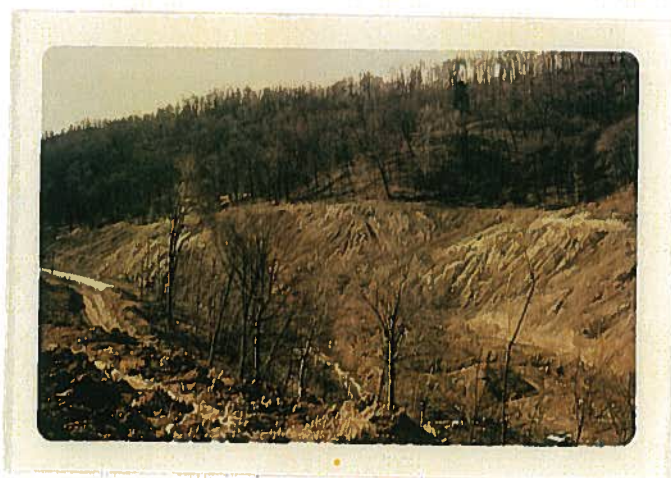
Figure 4-6

West side of Kilbuck Run Valley; looking south on I-279 from about Sta. 900; note slump bench (at level of arrow) and tilted trees  
March 7, 1969

The surface of these slump benches generally has relief of less than six ft. In places, the benches have minor closed depressions and topographic domes on them. Downslope from the slump benches, it is common to find large trees whose trunks are curved (convex downslope) because they have been involved in downslope movements of the landslide material during growth. Such trees of one- or two-foot trunk diameter indicate that the movement, at least in part, is old. The slide material may also contain large blocks of out-of-place Morgantown Sandstone that have broken free along joint planes and moved as much as several tens of feet downslope. Tabular "float" blocks of Ames Limestone in various attitudes (position with respect to horizontal) except the horizontal one may also occur on a bench surface or downslope from it, indicating that these blocks have moved away from their in-situ position in a claystone medium. One must be careful not to use elevations obtained from such float blocks in determining accurate elevations of the Ames Limestone as a reference bed.

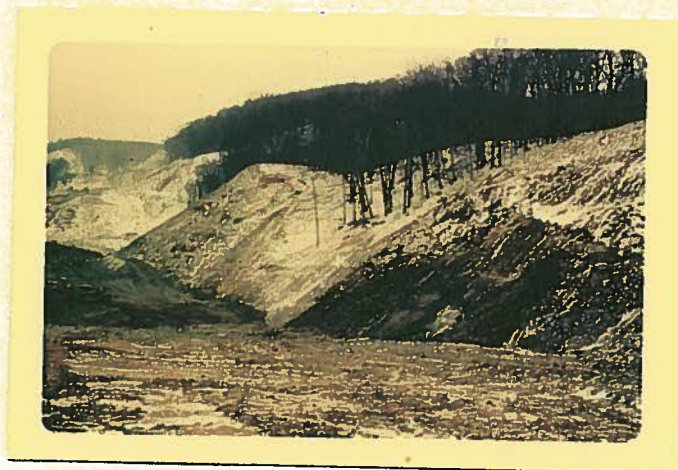
Figure 5-4

Panoramic view looking north from Sta. 900 on I-279; Slide B in right foreground; Slide A in left center; Jan. 8, 1968

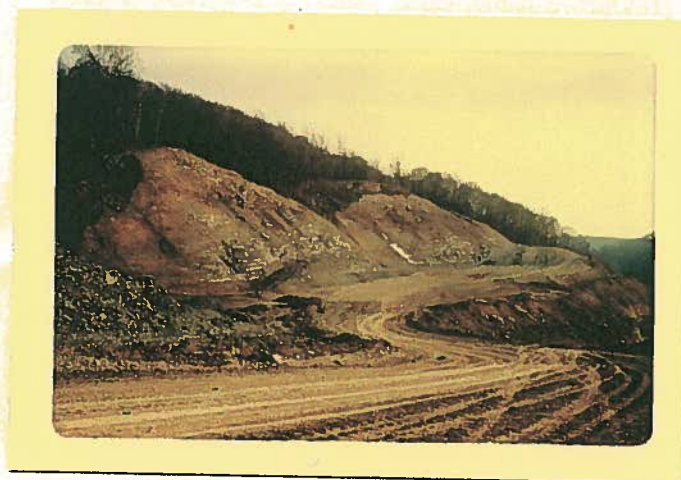
Figure 5-5

Panoramic view looking south from Sta. 915 on I-279; Slide A in left center; Slide B in right center; Feb. 28, 1969

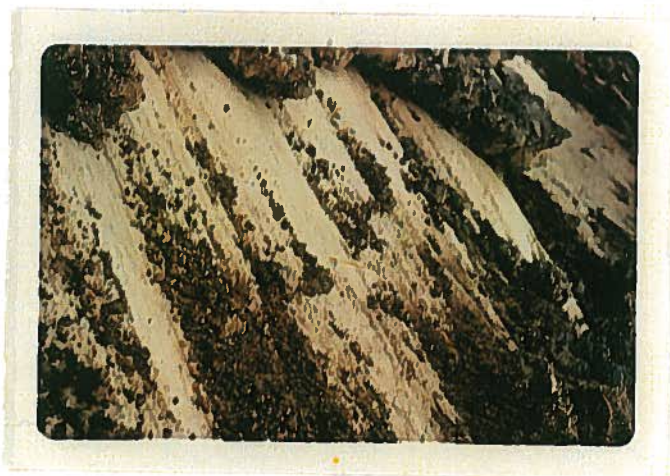
Figure 5-16

Closeup view of typical rear sliding surface;  
slickensided gray clay; 50° average dip;  
I-279, Sta. 932; May 20, 1969
