Walker, A.E., Moore, J.N., Grams, P.E., Dean, D.J., and Schmidt, J.C., 2020, Channel narrowing by inset floodplain formation of the lower Green River in the Canyonlands region, Utah: GSA Bulletin, https://doi.org/10.1130/B35233.1.

## **Data Repository**

## DR1-DR10: Aerial Photographs in the Vicinity of the Hardscrabble Trench

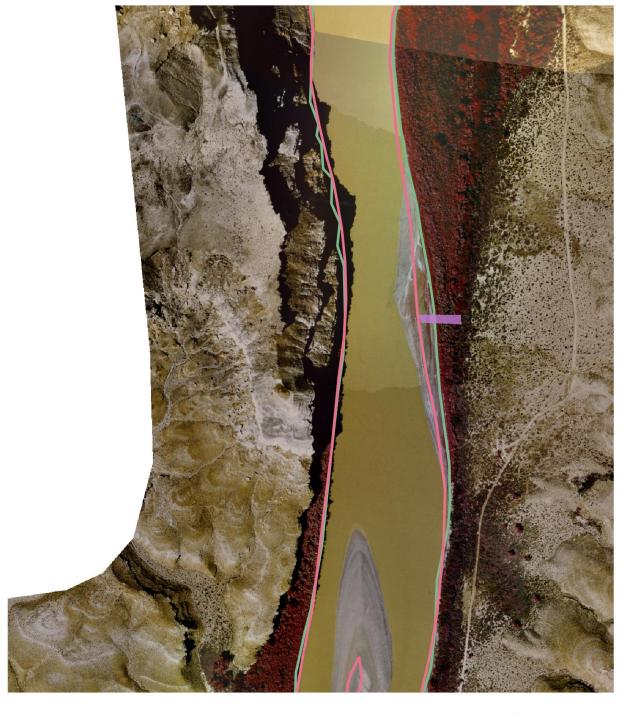
## Photo DR5: 1988-08-27, Bureau of Reclamation

Trench Location2014 bank lines1976 bank lines
