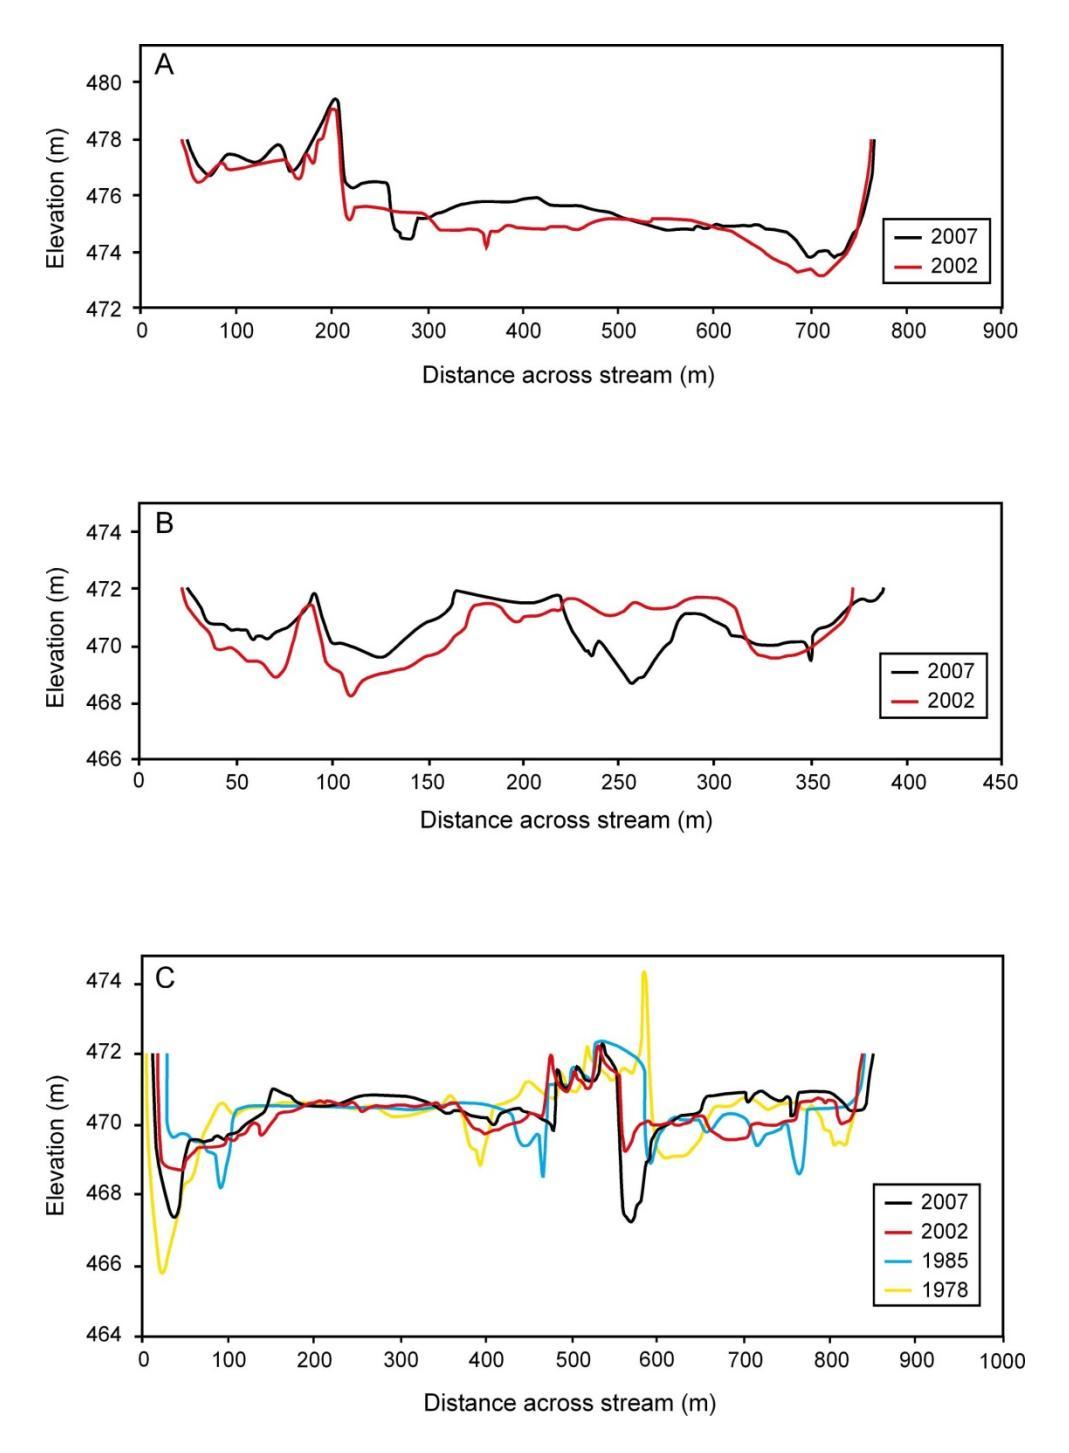
Figure DR1. Cross-sectional profiles at three locations surveyed pre- (2002) and post-flood (2007); also shown for section C are surveys from 1978 and 1985. Section A is located 4.3 km upstream of the study reach, section B is immediately downstream of the study reach and section 3 is 5.8 km downstream of the study reach. Sections A and B have been unaffected by the flood, experiencing both erosion and deposition but with no significant change to the maximum depths across the section, with maximum depth being ~0.5 m deeper in the pre-flood survey. Section C does show greater scour after the 2005 flood, with maximum channel depth increasing by over 1 m. However, this scour is spatially-restricted and similar to the depths of scour that could be expected from the other surveys. For example, the main channel was over 1.5 m deeper in 1978 compared to the post-flood survey in 2007. These changes in bed

height are likely due to the presence or absence of a unit bar in the cross-section rather than a widespread change in bed elevation.

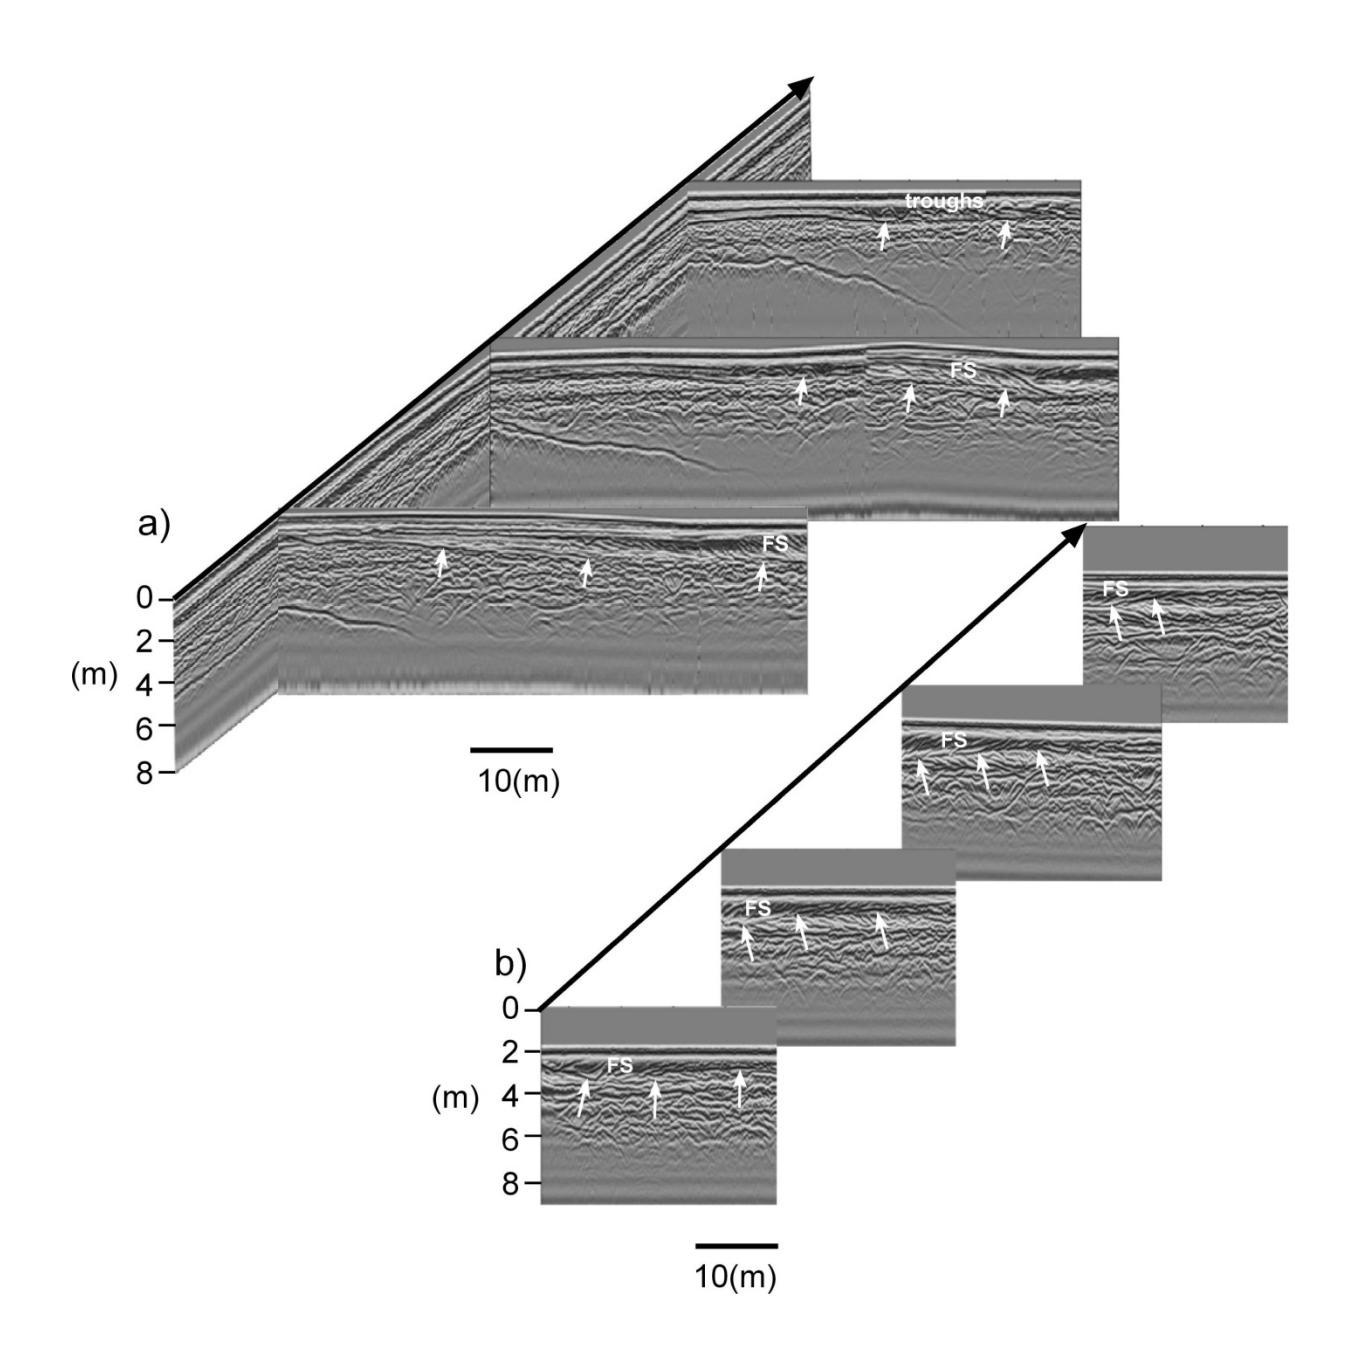
Figure DR2. Comparison of the thicknesses of unit bar deposits for bars formed: a) after the 2005 flood in annual floods, and b) during the 2005 large flood. Note that the foresets (labeled FS) produced at the margin of migrating bars are of the same size (the foresets thicken and steepen towards the bar margin). The base of the unit bar sets are indicated by white arrows and can be traced over several 10s of meters

between GPR survey lines. The style and scale of unit bar deposits thus appear similar despite the different discharges prevalent at the time of their formation.
